What a National Wood Flooring Inspector will be determining when asked to investigate a concern!

Acclimation----definition as follows

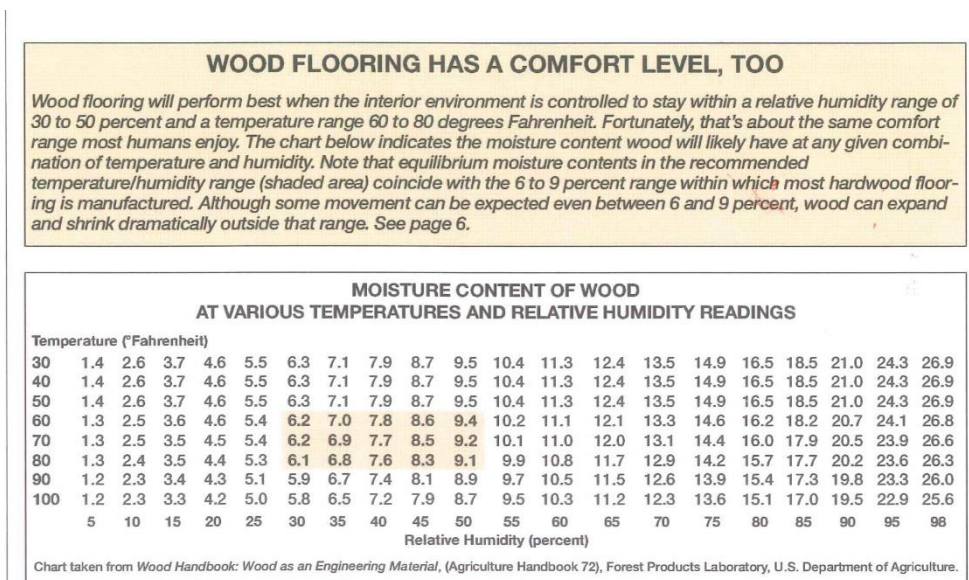
As stated in chart which

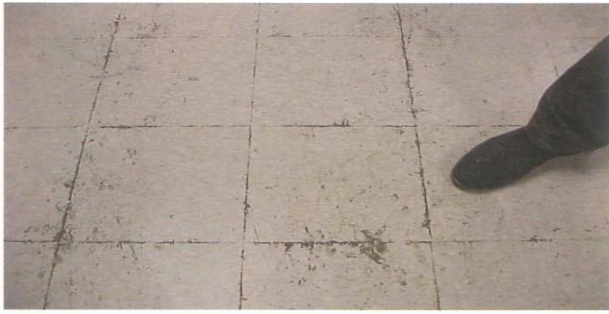
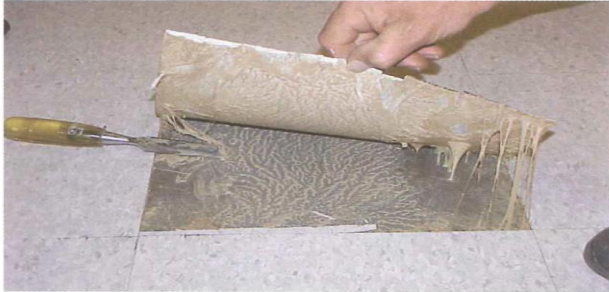
Figure 3-2. Adhesive oozing from joints (top) in recently-installed vinyl composition tile on a school floor. New tile (bottom) debonded due to moisture and high pH attack on new adhesive. (IMG16023, IMG16003)

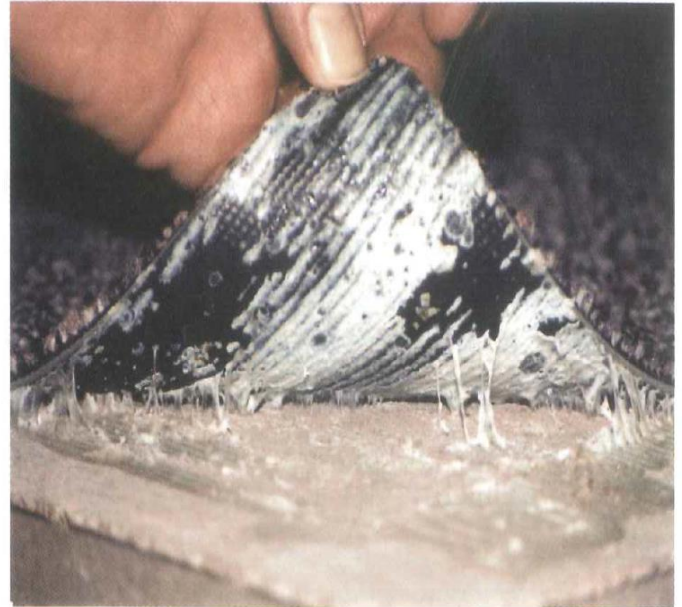
Figure 3-1. Due to excessive moisture and a high pH in the concrete surface, the adhesive under this vinyl backed carpet tile has reemulsified and has lost most of its holding strength. (IMG16042)

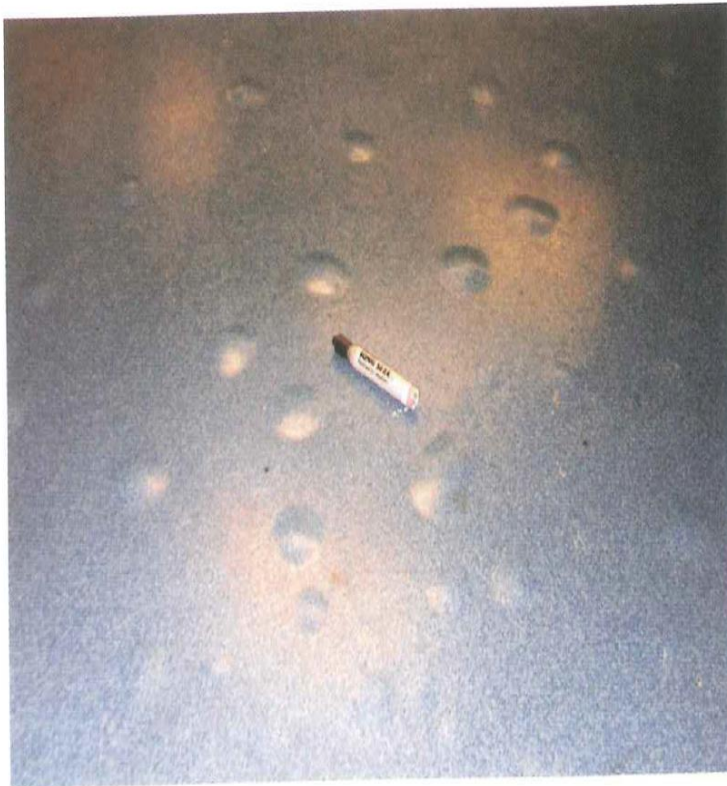
Figure 3-4. Osmotic blistering in epoxy floor coating (photo courtesy of Peter Craig, Concrete Constructives).

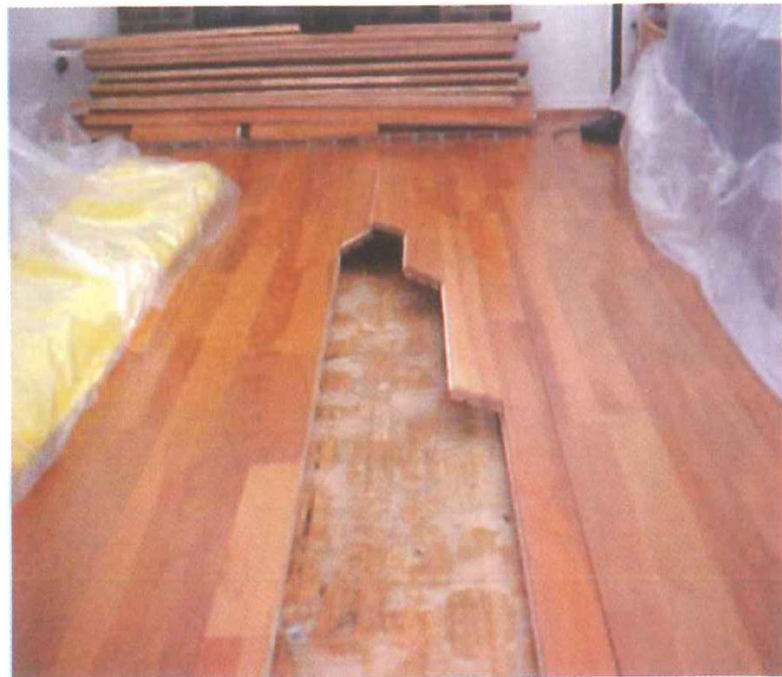
Figure 3-8. In this residence, wood flooring was glued directly to a damp concrete floor slab; the wood absorbed moisture from the slab, expanded, and buckled (photo courtesy of George Donnelly, Testing and Inspections).
